Technical Note

TN no. N-1562

title: REPAIR SYSTEM FOR DAMAGED COATINGS ON NAVY
ANTENNA TOWERS — PART II

NAVY
CIVIL ENGINEERING LABORATORY

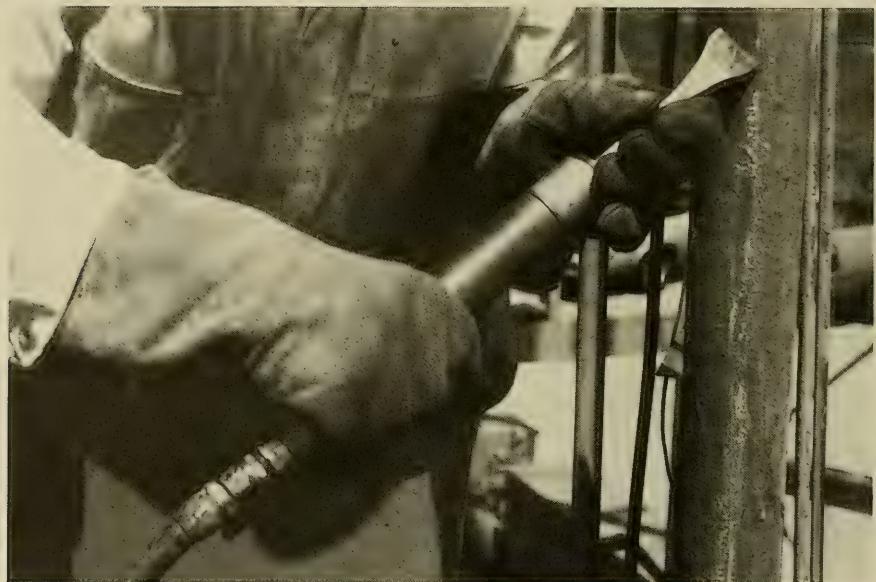
(b) Chiseling.

Figure 1. Portable backpack unit.

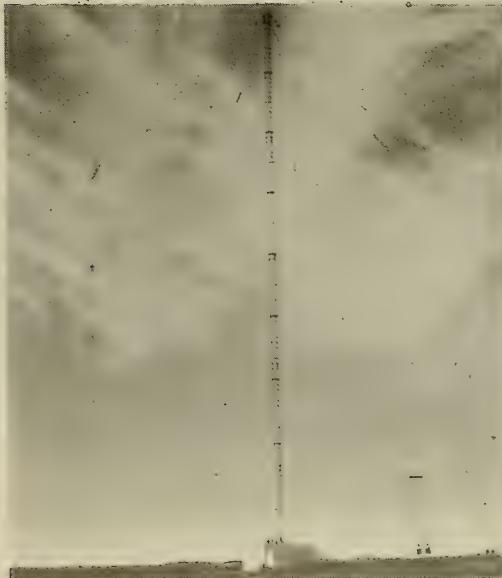
Antenna towers and supporting communication equipment are widely scattered throughout the world. Many are at remote locations that have very corrosive environments (Figures 2 and 3) and very limited maintenance services available. Thus, the greatest care must be taken in siting, designing for corrosion control, and planning maintenance if vital communication systems are to be kept operable.

Figure 2. Antenna field.

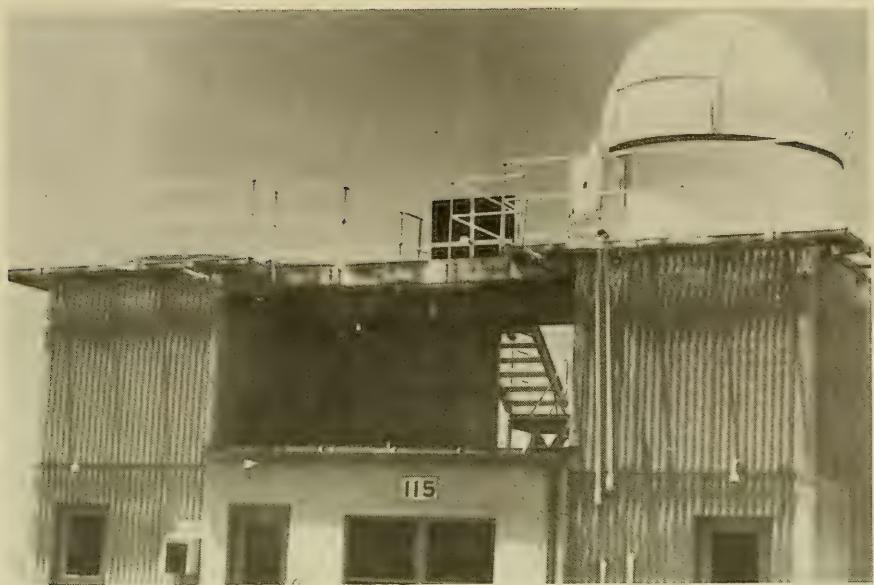
Figure 3. Communication facility.

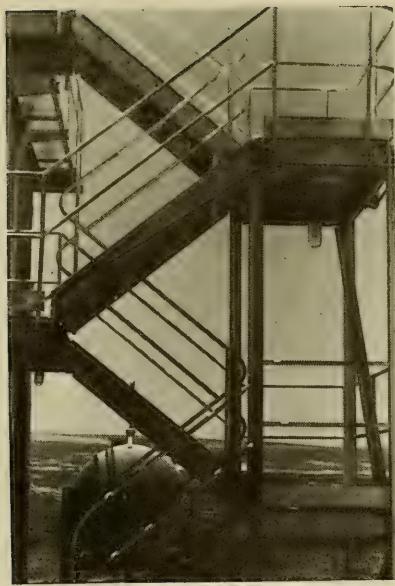
Box, rectangular, and tubular beams are much less susceptible to corrosion than tees, channels, and I-beams because the latter permit greater accumulations of salt, moisture, and other contaminants that accelerate corrosion or are more difficult to clean and coat. It is good practice to smooth all welds, edges, and other rough surfaces before coating to permit easier, more uniform coating application. Stairs, railings, ladders, and support trailers present irregular or inaccessible surfaces difficult to coat (Figures 7 and 8).

Tower 'stairs and railing.

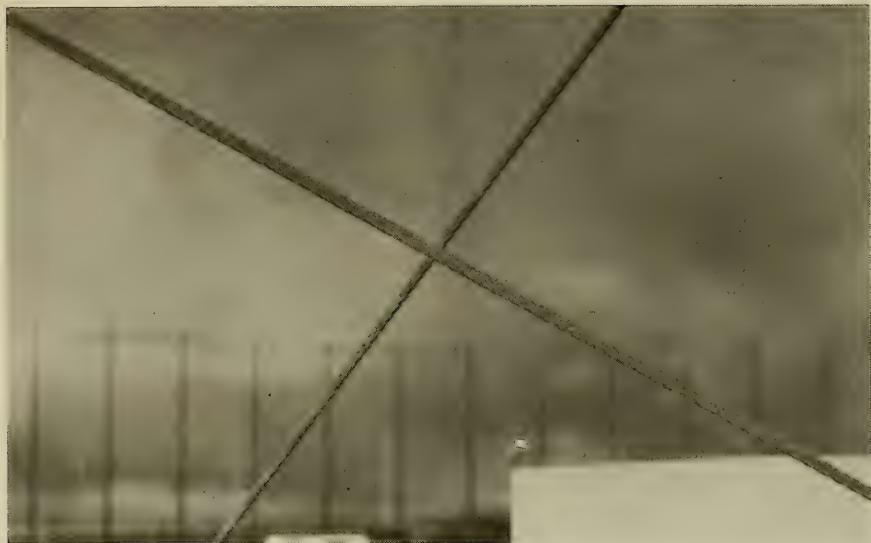
Guy lines should be placed so they do not contact each other (Figure 9) or structural members during high winds. The use of protective sleeves to prevent abrasion damage by such action is not an acceptable method of preventing contact (Figure 10).

Figure 9. Crossed guy lines.

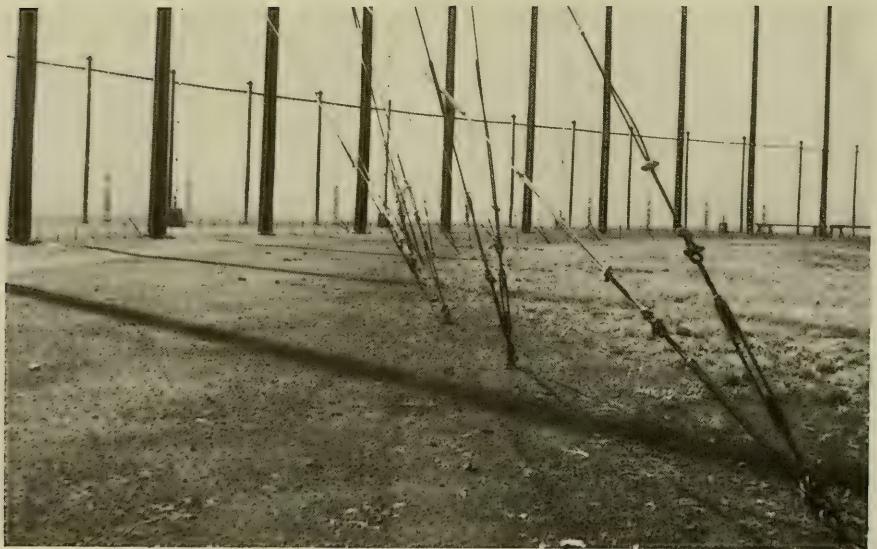
Fiberglass-reinforced epoxy rods (Figure 14) are frequently used on circularly disposed (Wullenweber) arrays (Figure 6) or other systems where high dielectric strength, high tensile strength, and low elongation are required. If their protective coating is lost by weathering and the glass fibers are exposed, a loss in strength can result. It is normally a better investment to replace than recoat such deteriorated rods. Also, the weakest component is the end connector (Ref 13); therefore, protective coatings are especially important in this area.

Figure 14. Glass-reinforced plastic guy line with dampener.
